**DEPARTMENT OF TRANSPORTATION**

Contract #: 04-0120F4Cty: SF/ALA Rte: 80 PM: 13.2/13.9File #: 69.28**WELDING INSPECTION REPORT****Resident Engineer:**Pursell, Gary**Address:** 333 Burma Road**City:** Oakland, CA 94607**Report No:** WIR-002428**Date Inspected:** 13-May-2008**Project Name:** SAS Superstructure**OSM Arrival Time:** 2300**Prime Contractor:** American Bridge/Fluor Enterprises, a JV**OSM Departure Time:** 800**Contractor:** Zhenhua Port Machinery Company, Ltd (ZPMC), Changxing Island **Location:** Shanghai, China**CWI Name:** An Qing Xiang**CWI Present:** Yes No**Inspected CWI report:** Yes No N/A**Rod Oven in Use:** Yes No N/A**Electrode to specification:** Yes No N/A**Weld Procedures Followed:** Yes No N/A**Qualified Welders:** Yes No N/A**Verified Joint Fit-up:** Yes No N/A**Approved Drawings:** Yes No N/A**Approved WPS:** Yes No N/A**Delayed / Cancelled:** Yes No N/A**Bridge No:** 34-0006**Component:** Tower**Summary of Items Observed:**

# WELDING INSPECTION REPORT

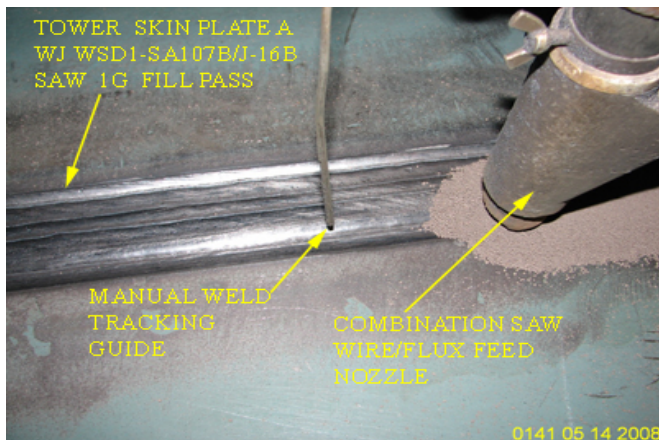
The QA Inspector randomly observed ZPMC welder Xia Yonglin ID Number 048882, utilizing the Submerged Arc Welding (SAW) Process in the 1G Position (Flat Groove) with ZPMC Weld Procedure Specification (WPS) WPS-B-T-2221-B-U3c-S, to weld the fill pass in Weld Joint (WJ) WSD1-SA107B/J-17B on Tower Skin Plate A Sub-Assembly SA107(W) piece marks p456(W) + p375(W) to p228(W). The QA Inspector randomly observed ZPMC CWI An Qing Xiang monitoring weld parameters. The QA Inspector also randomly monitored weld parameters and recorded them as follows: 640 amps, 32.4 volts with a travel speed of 600 millimeters (mm) per minute. The weld parameters appeared to comply with contract requirements. The attached photograph provides additional detail.

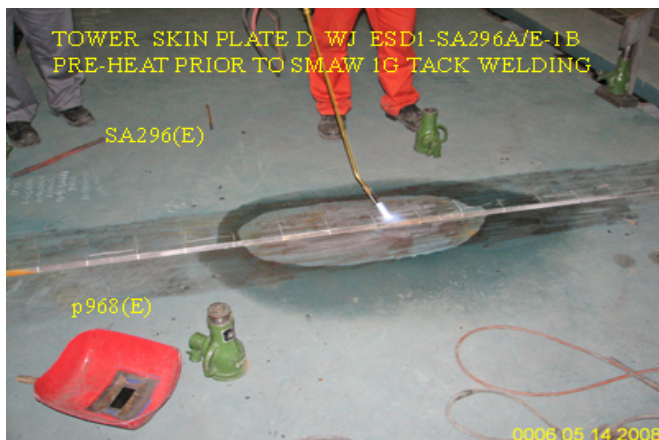
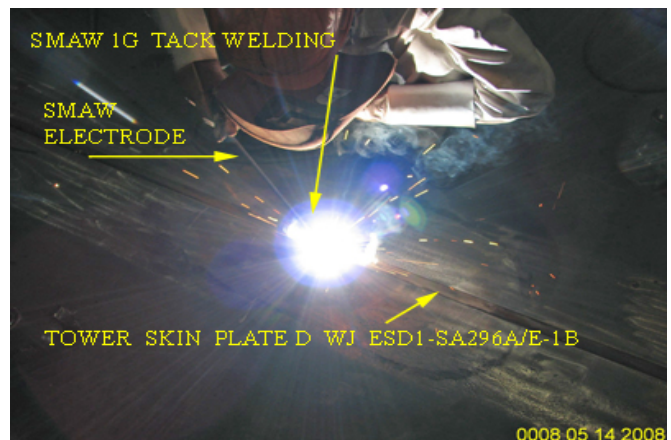
The QA Inspector randomly observed ZPMC welder Zhai Qingshan ID Number 058026, utilizing the Shielded Metal Arc Welding (SMAW) Process in the 1G Position (Flat Groove) with ZPMC WPS WPS-B-P-2211-B-U3b, to tack weld the splice between piece marks SA296(E) and p968(E) in WJ ESD1-SA296A/E-1B on Tower Skin Plate A Sub-Assembly SA296(E). The QA Inspector randomly observed ZPMC CWI An Qing Xiang monitoring weld parameters. The weld parameters appeared to comply with contract requirements. The attached photographs provide additional detail.
